Survey on an acute occupational poisoning event caused by simple asphyxiating gas

Hunan Prevention And Treatment Institute For
Occupational Diseases

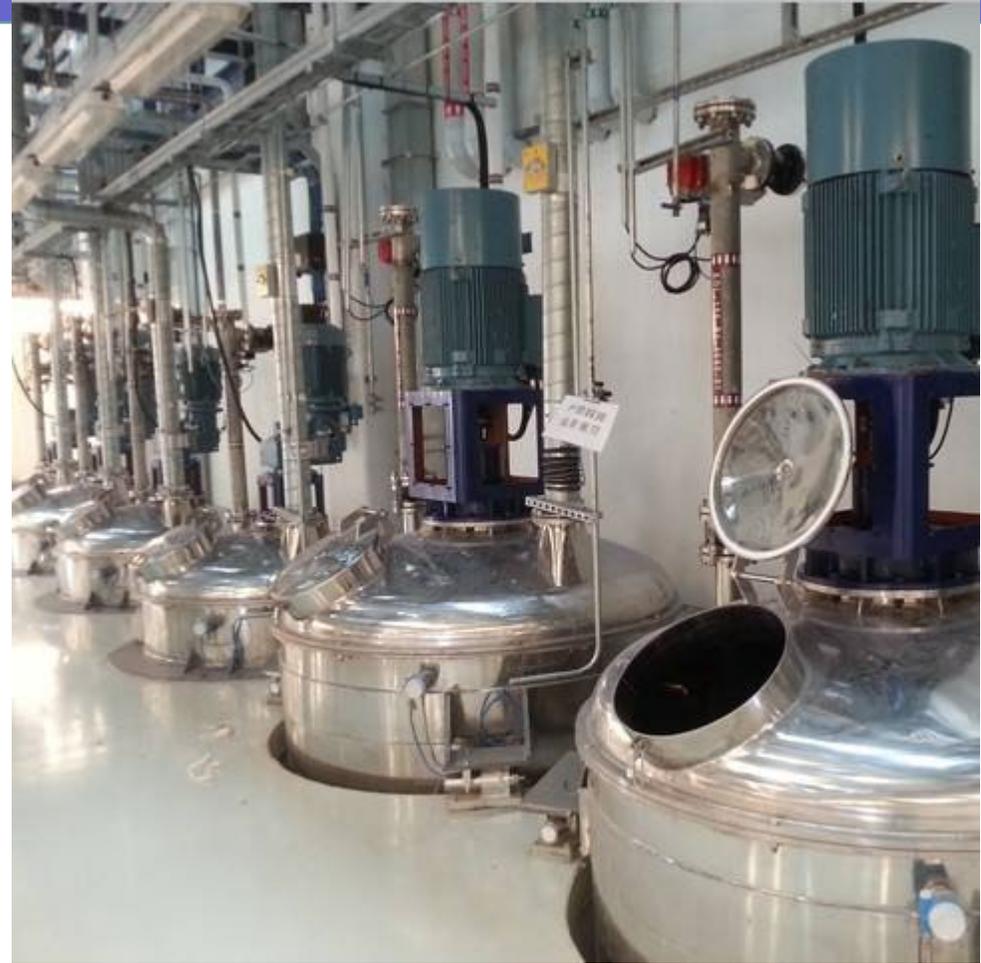
On-site environmental investigation:
Investigators arrived at the poisoning site the next day to investigate the situation, including reactor ventilation measures, production process and other related information, and determine the concentration of oxygen, phenol, toluene and hydrochloric acid in the reactor.

- On-site investigation: the reactor is dry without liquid residue. On-site air detection at the bottom of the reactor: the concentration of phenol, toluene and hydrochloric acid was within the normal range. Oxygen content was **10.0%** detected in the field. There was no stipulated oxygen content in the exposure limit of harmful factors in domestic workplace. Oxygen content in normal air was **20.93%**.
